## REQUEST FOR QUOTES 2025-008 DEMOLITION & REMOVAL OF BUILDING(S)

**Date:** November 20, 2025 – **Amendment: January 15, 2026**  
**Project:** Demolition and Removal of Building(s) and Debris  
**Address:** 160 Back Bay Loop Road, Back Bay, NB (PID# 15009236)

# Inspection report

## 160 Back Bay Loop Road

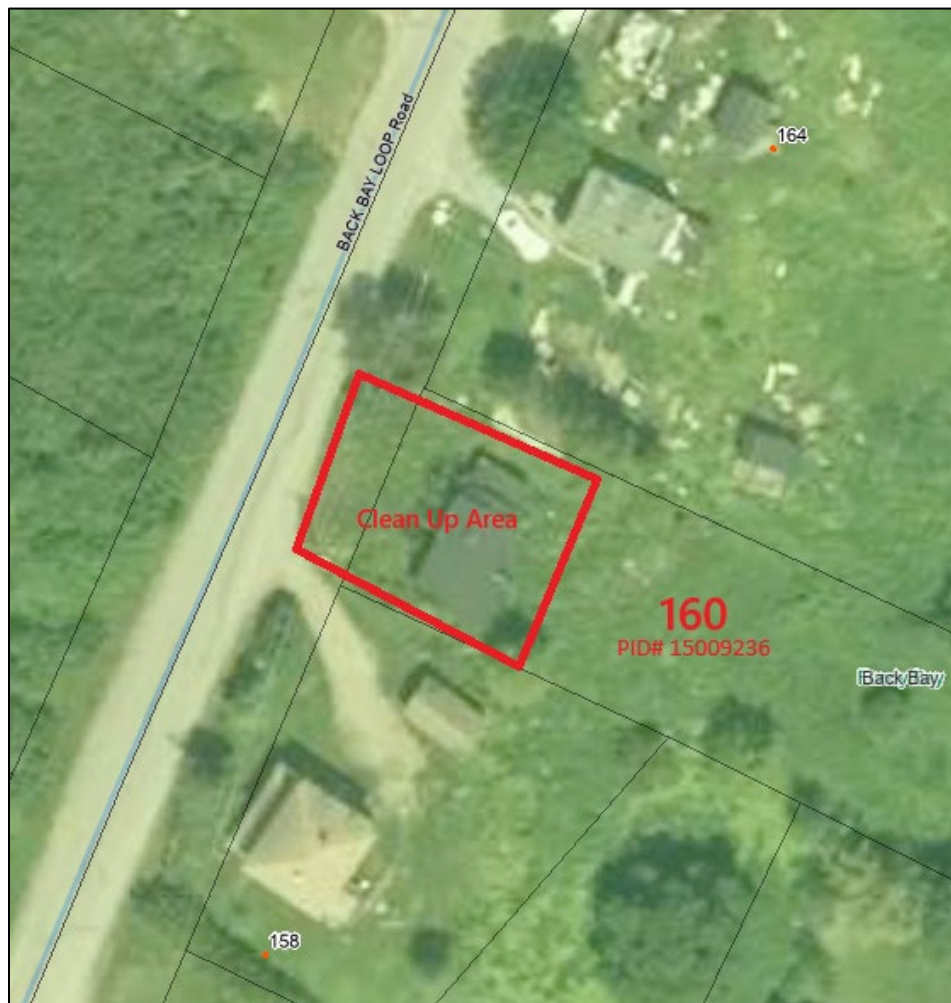
(above) Clean Up Area

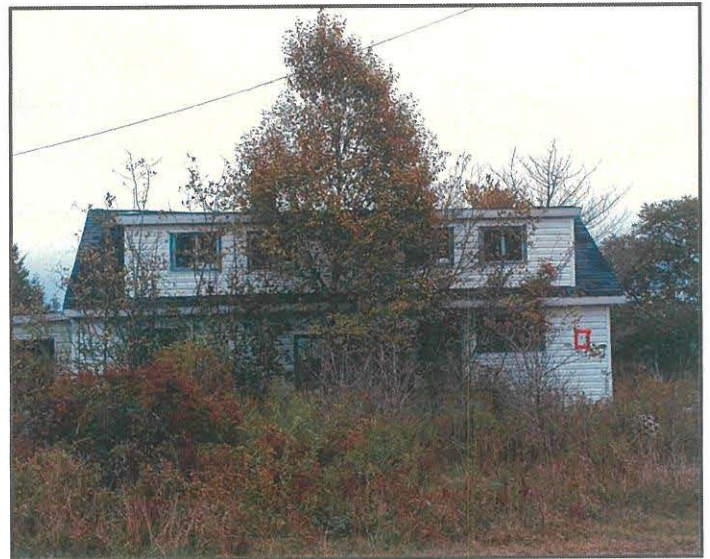
Pursuant to section 144(2) of the *Local Governance Act*, a notice of inspection was sent to the property owner by registered mail to the address listed on the property's Land Title registry, as well as affixed to the building itself. *160 Back Bay Loop Road*

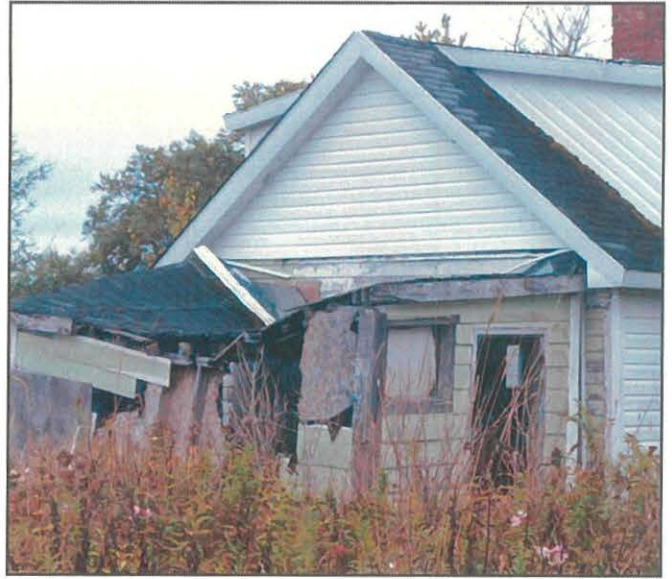
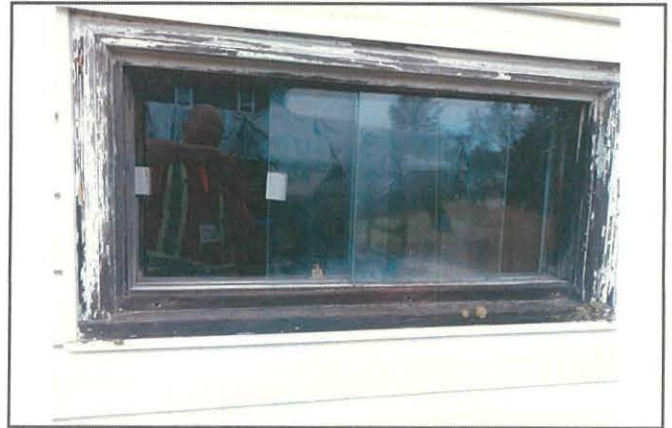
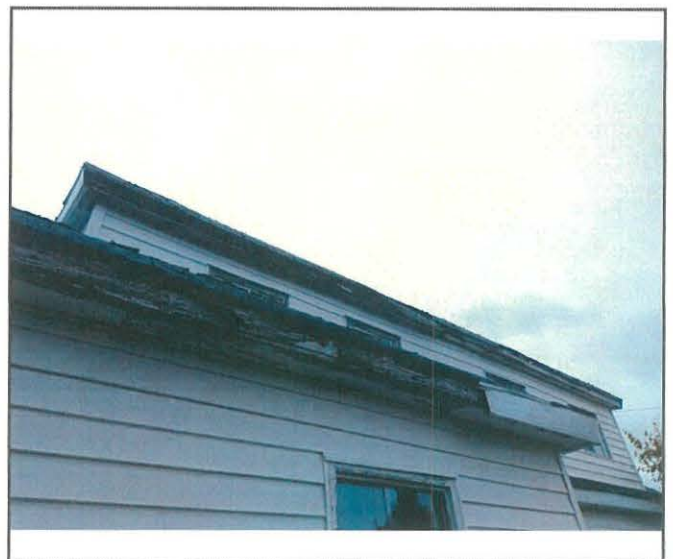
The building on the property is a two-storey, approximately 83m<sup>2</sup> structure in a fairly degraded condition. An element on the north side of the structure - clearly an addition - has simply collapsed and separated from the main structure itself. (See image next page).

The shingles of the roof are in an acute state of disrepair, and the loss of shingle integrity in several locations means an increased likelihood of water penetration. Of notable concern would be the exceptionally flat roof over the "barn-style" dormers on the second story. Shingles are not, nor ever have been, permitted to be used on roofs of such a shallow slope. (The least slope permitted since 1970 is a 2:12 slope. This certainly appears to be less than this). In any event, the minimal slope combined with the degradation of the shingles means it is almost certain that water has penetrated the superstructure in this area.

There is no evidence of proper flashing, nor appropriate finishing techniques at the junction of the dormer walls and the adjacent roof. Again, this leads to a strong likelihood of water penetration into the superstructure.

The windows are an old wood-sash framing assembly, and all of the windows in the structure demonstrate varied states of advanced decay. The windows have long since lost the ability to prevent water from entering the structure.

The soffits are in an advanced state of degradation. In almost all areas of both the east and west gable ends, the fascia has been reduced to a state of dysfunction. On the east side, the aluminum fascia has been lost in a few locations, both on the main roof and a dormer assembly. On the west, where the aluminum fascia is still present, water damage in the soffit assembly itself is proof of water penetration through the degraded roof. Water has clearly penetrated the building in several locations and for a prolonged period of time. Evidence of rafter/truss member degradation is evident through the varied holes observable on both east and west soffit areas.

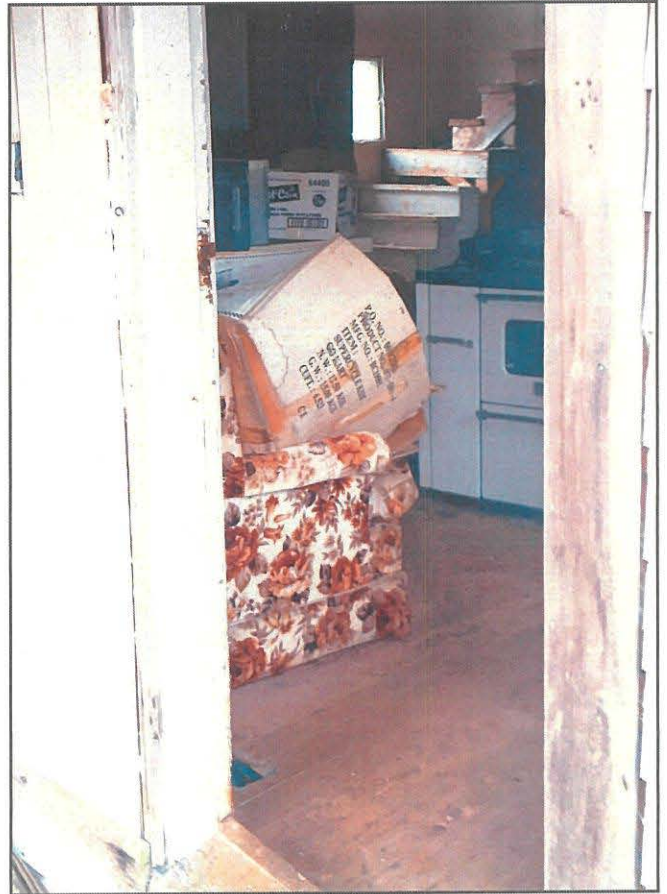
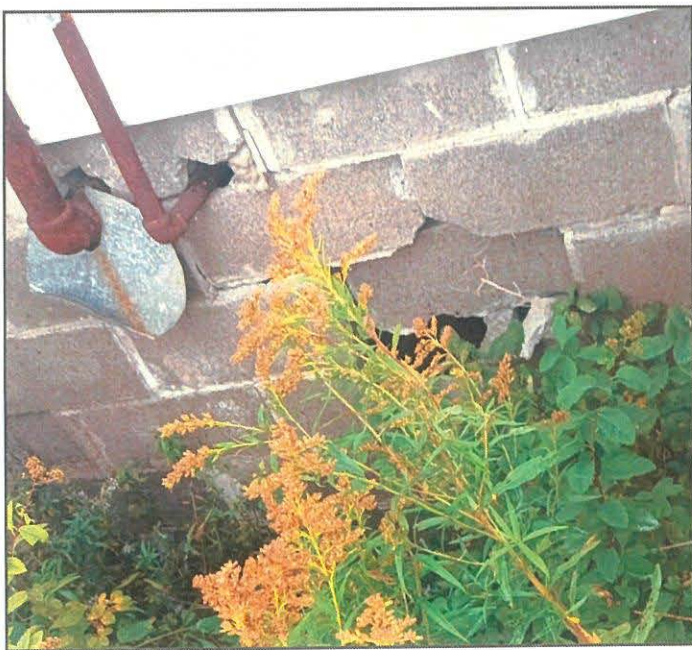
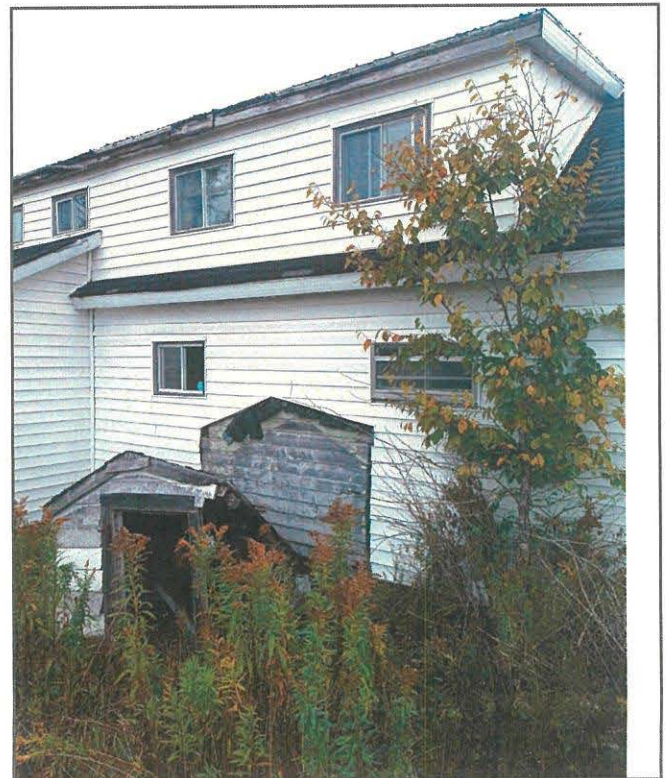
Through the collapsed addition on the north side, a door is open. This renders the building readily accessible, and the interior is readily visible without entry. Thus, it can be seen that a box on a sofa shows evidence of water damage. The frame around the door is in a state of degradation consistent with water penetration. The stairs to the second storey are readily visible and are in no way compliant to any common version of the National Building Code.

The foundation of the structure is an old concrete-block assembly. It is fractured in several locations and completely failing in one.

At the rear of the house, a protective assembly - aka a "doghouse" over the basement entrance has completely collapsed. The basement is readily visible, and the floor is coated with a rust-hued slime.

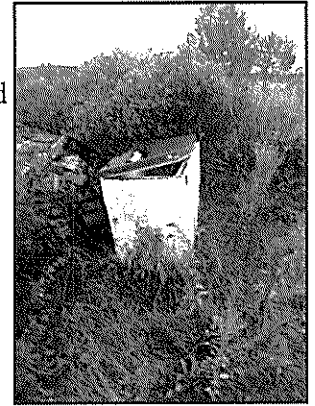
There are remains of a shed or other collapsed structure. This is considered debris, and timely removal should be ordered.

Likewise, there is an old freezer - presumably dysfunctional - between the collapsed eastern addition and the collapsed shed. It ought to be removed.
